EMBANKMENT CRITERIA AND PERFORMANCE REPORT

FALL RIVER BASIN

COLD BROOK LAKE, SOUTH DAKOTA

Omaha District

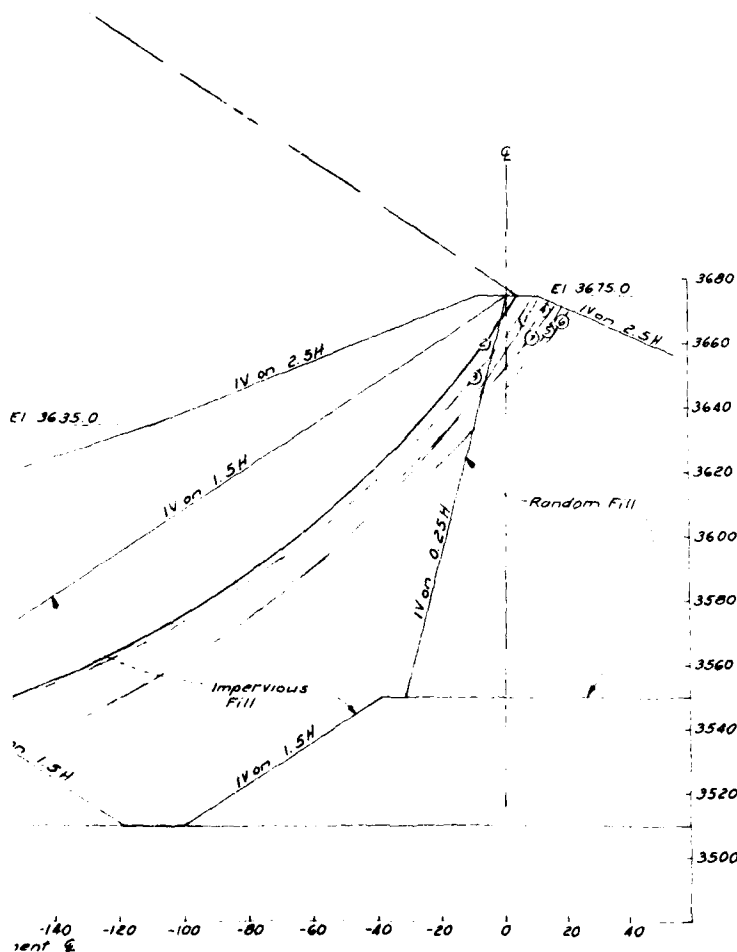
1. In Figure 3 the factors of safety above and to the right of the heavy line are not influenced by that particular pool elevation. These values have not been considered in evaluating the critical factor of safety.
2. Factors of safety in Figure 3 appended with a number appear in Figure 4 with the appended number as the critical arc number. This same number is used in Figure 1 to denote arc centers and arcs.
3. * Denotes lowest factor of safety.
4. Required factor of safety is 1.2 at spillway pool and 1.0 at surcharge pool. Actual factors of safety for these pools are 1.32 and 1.43 respectively.
5. For hand run computations of the critical arc see Plate 2.

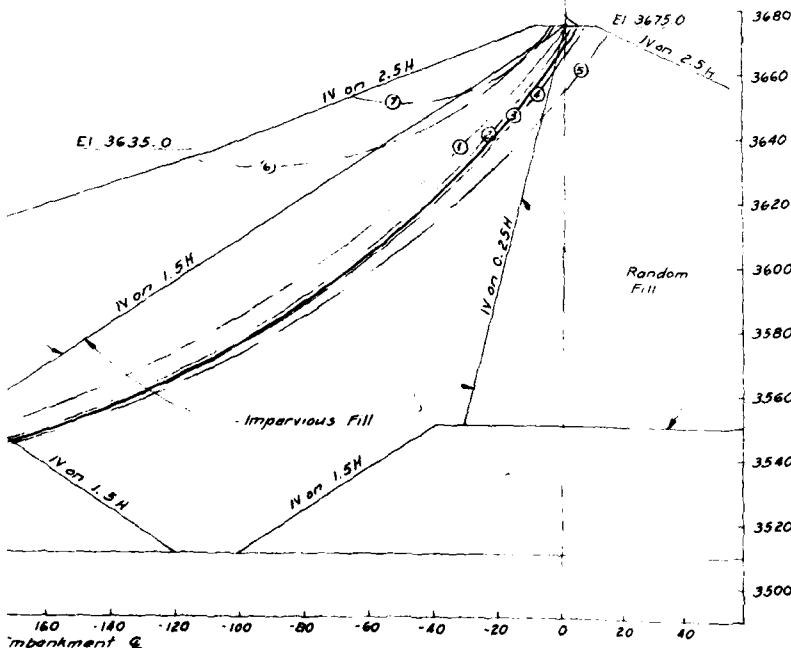
1. In Figure 3 the factors of safety above and to the right of the heavy line are not influenced by that particular pool elevation. These values have not been considered in evaluating the critical factor of safety.
2. Factors of safety in Figure 3 appended with a number appear in Figure 4 with the appended number as the critical arc number. This same number is used in Figure 1 to denote arc centers and arcs.
3. * Denotes lowest factor of safety.
4. Required factor of safety for Partial Pool Case without considering earthquake conditions is 1.5 and with earthquake considerations the required factor of safety is 1.0. Actual factors of safety were found to be 1.25 without earthquake and 1.03 with earthquake.
5. For hand run computations of the critical arc see Plate B-4.

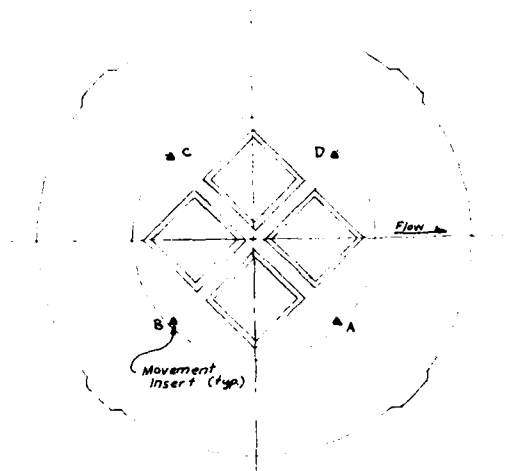
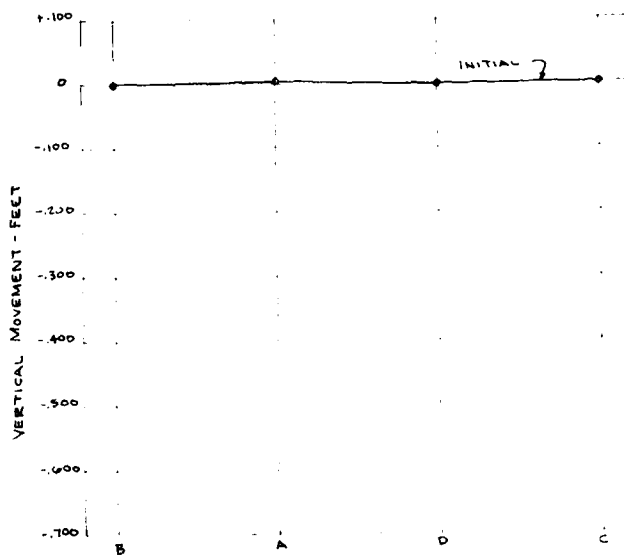
INTAKE STRUCTURE
PLAN OF TOP SLAB
N.T.S.

5.4. Intake Structure Elevation Points. Plate 21 shows the location of the points on top of the intake structure. This plate also
